ATTACHMENT G
Point Sources Along the Merrimack River in Lawrence, Massachusetts

Area surveyed: Merrimack River from the Lawrence-Methuen-Andover Line to the Lawrence-Methuen-North Andover Line, and the North Canal

August 8, 2000:

Area surveyed: Merrimack River upstream of the dam to the Lawrence-Methuen-Andover Line
Weather: Clear, approximately 75°F

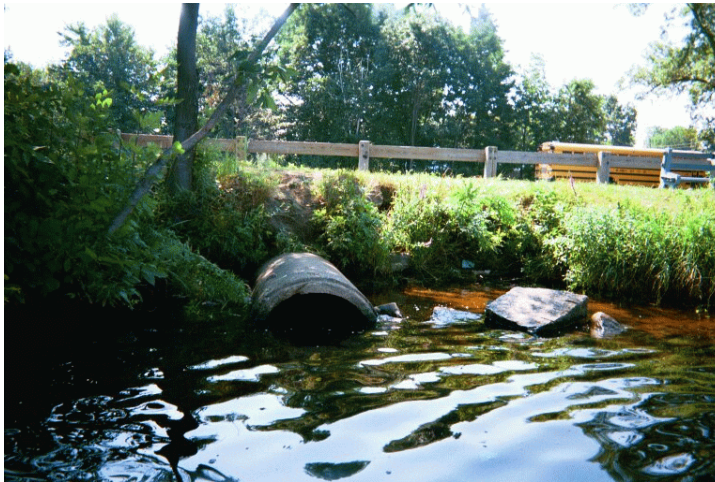
Pipe # 01:	Approximately 36" diameter concrete pipe. Pipe partially submerged. Located adjacent to the Community Boathouse parking lot. No flow.
------------	---

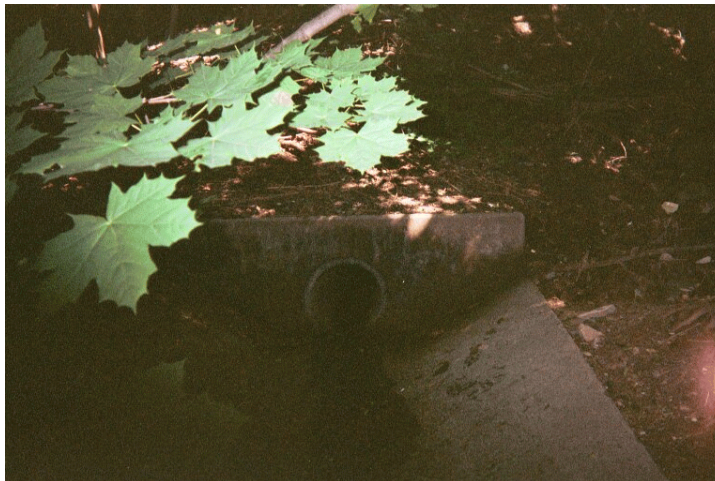
Pipe # 02:	Approximately 24" diameter concrete pipe with concrete sluiceway. <i>Pipe flowing approximately 5 gpm. Discharge was clear with no odor.</i> Located in a wooded area approximately 30' from the Merrimack River.
-------------------	---

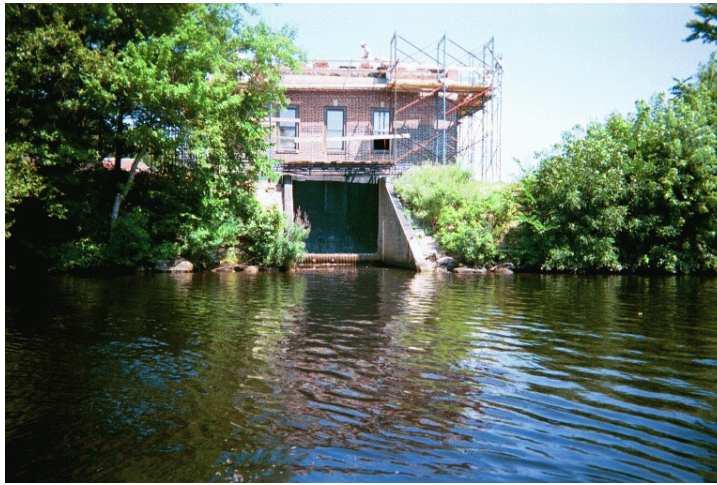
Pipe # 03:	Lawrence Municipal Water Supply System intake. Concrete structure with bar rack.
------------	--

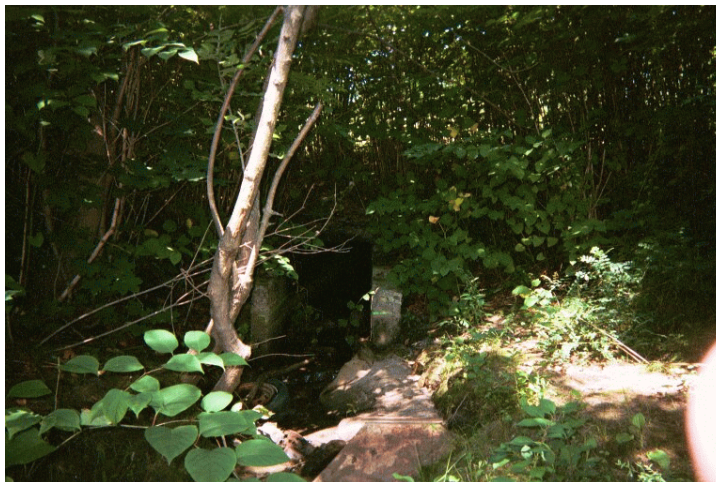
Pipe # 04:	Approximately 36" wide rectangular concrete culvert. <i>Flowing approximately 10 gpm. Discharge was clear with no odor.</i> Located in a wooded area approximately 30' from the Merrimack River.
------------	--

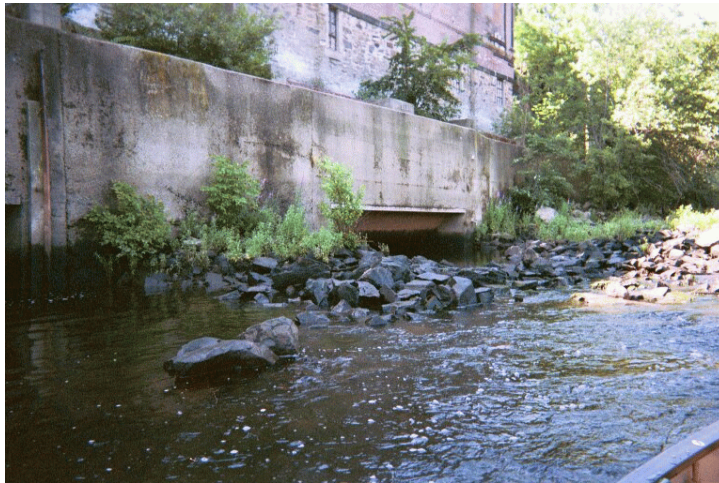
**Pipes # 05
and # 06:**

Two (2) approximately 12' wide rectangular concrete culverts. Both partially submerged. *Both flowing approximately 100 gpm. Discharge was clear with no odor.* Located behind Merrimac Paper.

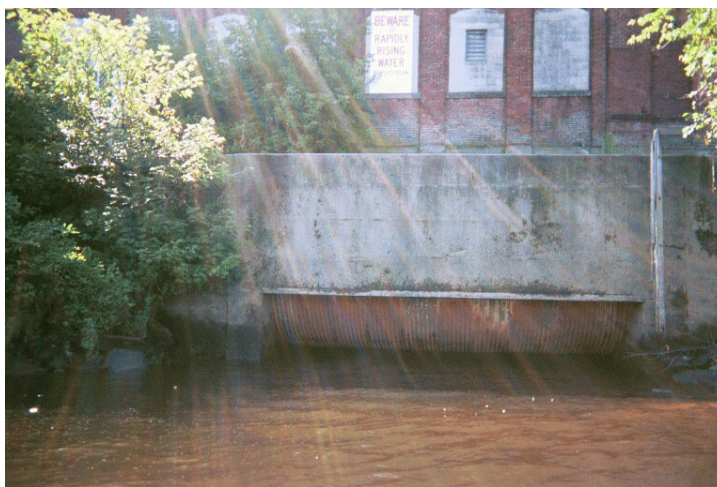
Pipe # 07:

Approximately 12' wide rectangular concrete culvert. Partially submerged. *Trickle flow.* Located behind Merrimac Paper.

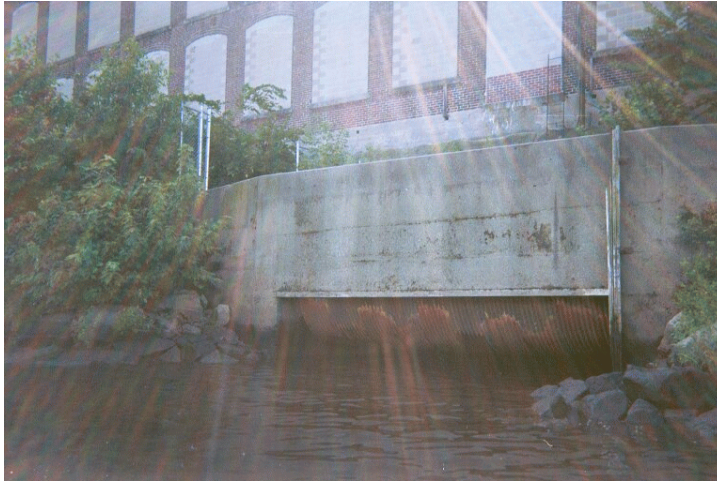
Pipe # 08:	Approximately 12' wide rectangular concrete culvert. Partially submerged. No flow. Located behind Merrimac Paper.
------------	---

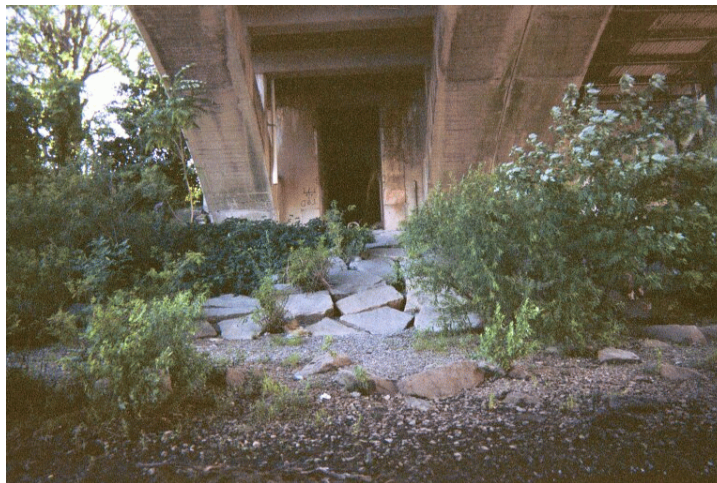
Pipe # 11:	Approximately 16" diameter concrete pipe. Located under the downstream side of the south abutment for the Joseph W. Casey Bridge. No flow.
------------	--
